PA 31 Series Hydraulic Filter Housing
Failures

AWB 29-003 **Issue :** 1
Date : 11 August 2008

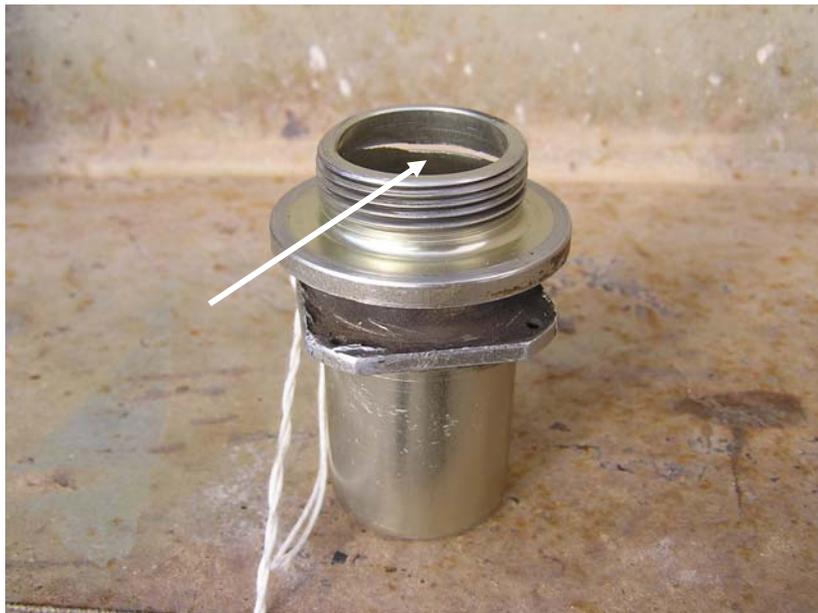
CASA Service Difficulty Reports indicate that the undercarriage system hydraulic filter failure occurs in the threaded portion of the filter. Failure of the filter threads allows system hydraulic oil to be discharged overboard under pressure, severely depleting hydraulic system fluid. The reports indicate that in each case, the crew has been able to use the emergency system to deploy the undercarriage for landing.

At each hydraulic system filter inspection/change, conduct a close visual inspection the hydraulic filter housing thread roots for cracking using a 10X magnifying glass and discard all suspect filter housings.
