Airworthiness Bulletin

AWB 37-002 Issue 2 - 8 September 2021

Aircraft Gyro Instrument Vacuum / Pressure Systems Functional Testing

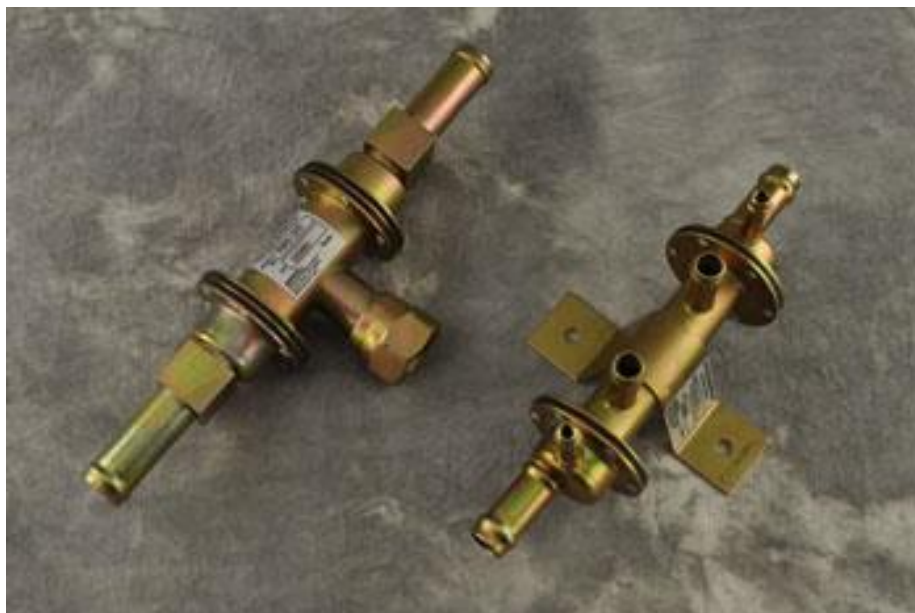
Figure 1: Typical manifold check valves

To provide basic guidance on the maintenance and system functional checks of the vacuum system manifold valve which is found installed in twin engine aircraft with two engine-driven vacuum pumps and in single engine aircraft equipped with one engine driven pump and one standby electrically driven pump (See Figure 1).

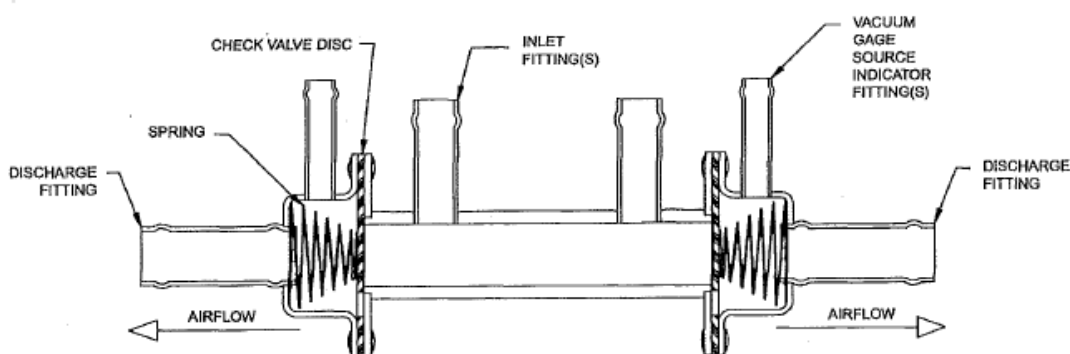
Figure. 2: Typical vacuum system manifold valve.

1H5 Series (all dash numbers) — Check Valve Manifolds (Vacuum System)

Figure 1
(1H5-2 Shown)

Total loss of vacuum or pressure supply to all air-driven gyroscopic navigation and flight reference instruments can occur in twin engine aircraft when both pumps fail at the same time, or when just one pump (or one engine) fails and the critical check valve in the vacuum system manifold fails. Single engine aircraft equipped with a back-up vacuum pump will also suffer total vacuum system failure if the engine and/or pump fails and the critical check valve in the vacuum system manifold fails, even though the standby vacuum pump is running.

1. Conduct functional checks of twin-pump vacuum systems as described in this AWB and/or manufacturer's data during engine runs, and particularly when anticipating IFR operations.

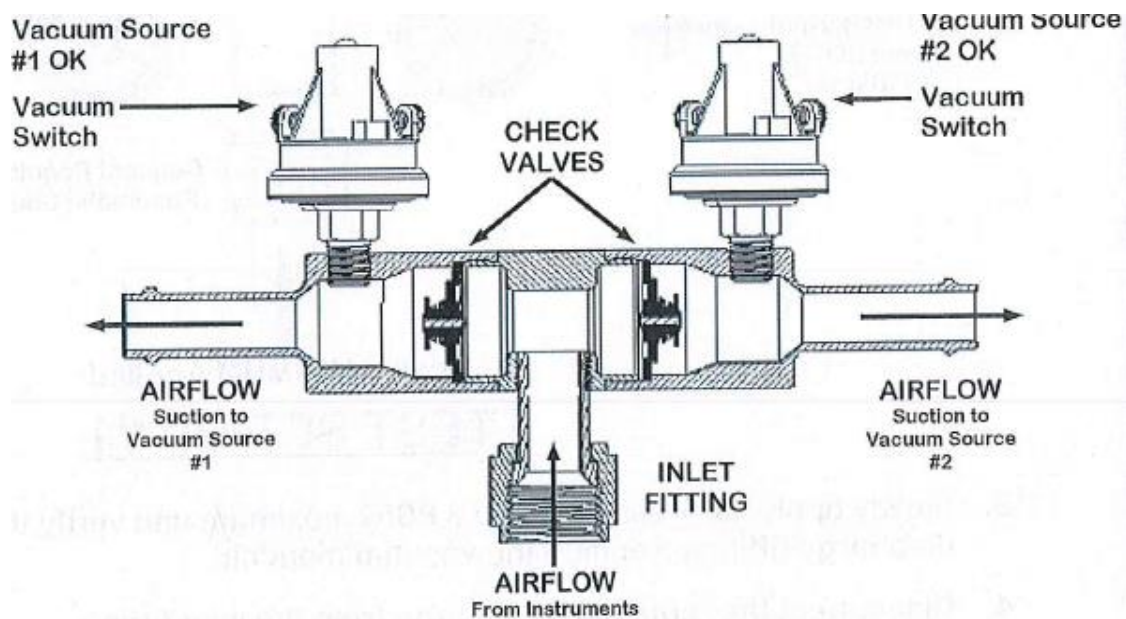
Figure. 3 Typical vacuum system manifold valve.

The manifold valve is intended to automatically isolate or seal off an air leak introduced by the non-functioning air pump. This allows the functioning air pump to continue to provide air for the air-driven instruments. However, should the manifold valve be unserviceable at the time one pump or engine fails, the result is the loss of vacuum or pressure supply to all air driven gyroscopic flight and navigation instruments.

Although the aircraft and manifold valve manufacturers provide periodic functional bench testing requirements and a retirement life for the manifold valve, manifold valve failure may still go undetected while in service between such inspections. This is because if both engines, each equipped with a serviceable vacuum pump are started in short succession, the isolation function of the manifold valve is not specifically tested, due to the vacuum sources quickly becoming 'balanced', extinguishing the system failure indicators.

To ensure the vacuum or pressure manifold is working correctly, start one engine and check that the vacuum/pressure is established before starting the other engine. At the end of the run, shut down the engine that was started first and let the other engine keep running.

Such continual checking is justified, even when the manufacturer's bench test and retirement life is adhered to, because the manifold valve typically uses 'rubber' flaps and seals which deteriorate at an unpredictable rate due to variations in factors such as heat, air pollution and contamination - from a failed pump for example. A failed manifold valve may also allow in-flight contamination of the serviceable pump with failed dry air pump
